Inspection Report

Minerals Regulatory Program

| Mine Name: Blawn 1-4 SMO Mine | Permit Number: S/001/0073 |

Purpose of Inspection: Evaluate 2014 regrading work

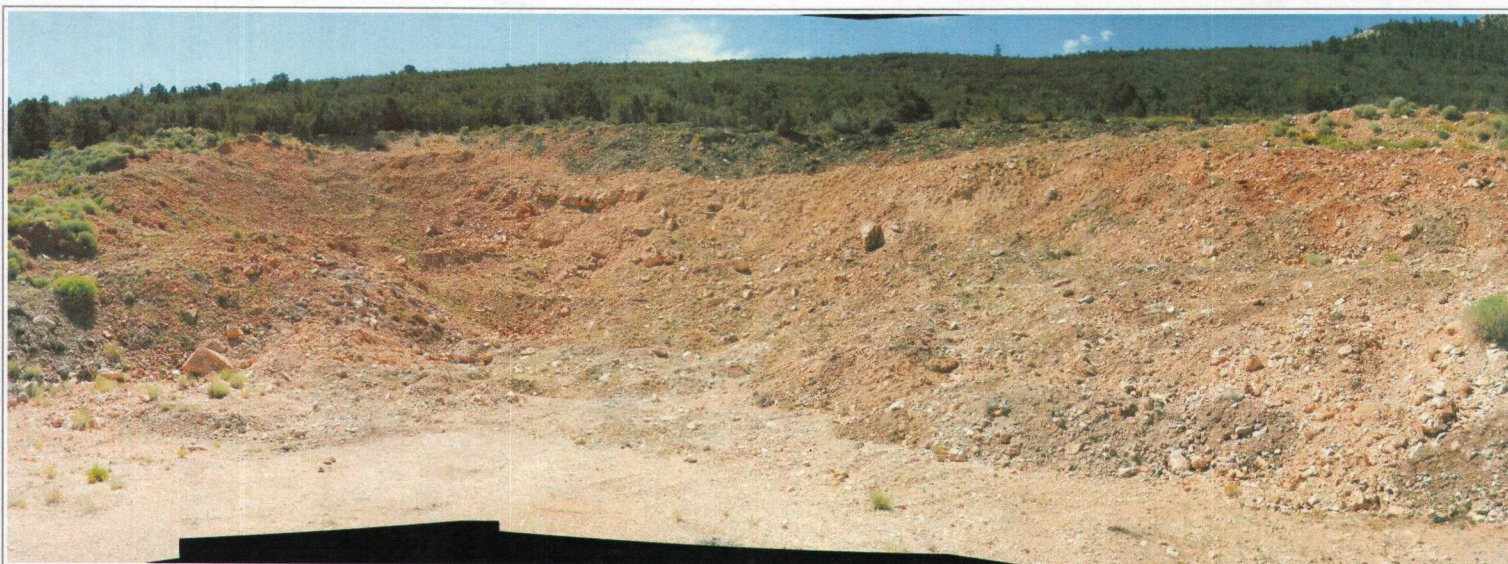
Graded, terraced slopes and depression at the toe of the slopes. Note the outcrop in the center of the photo near the top. Stitched photo.

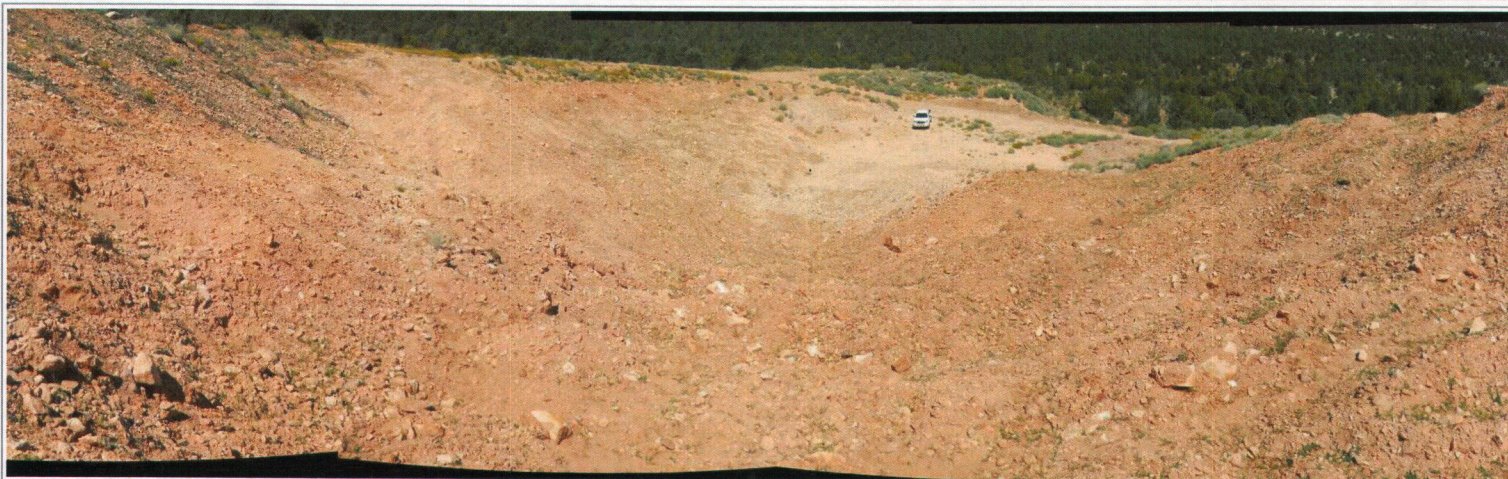
View of slopes from the top. Note the vegetation coming in. The rabbitbrush-covered dumps are visible beyond the truck and across the road.

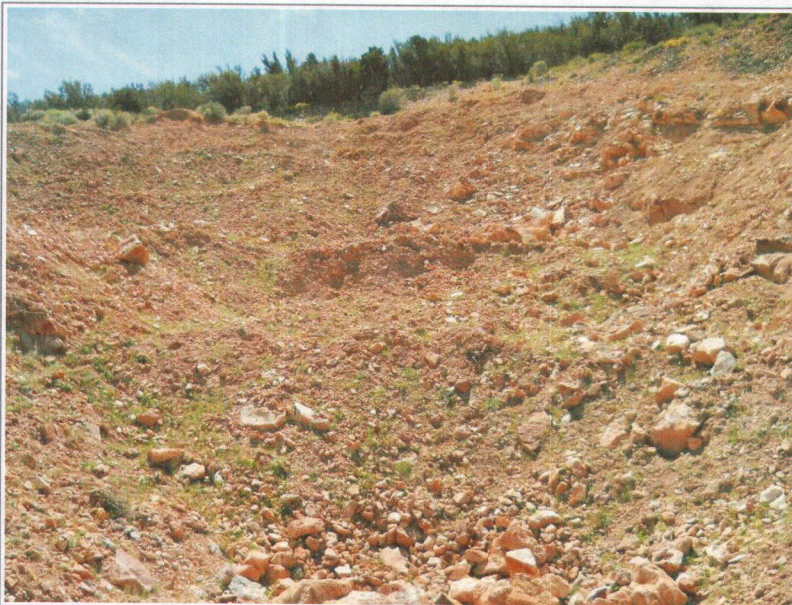
View of slope from the toe. Note bedrock exposures and vegetation.

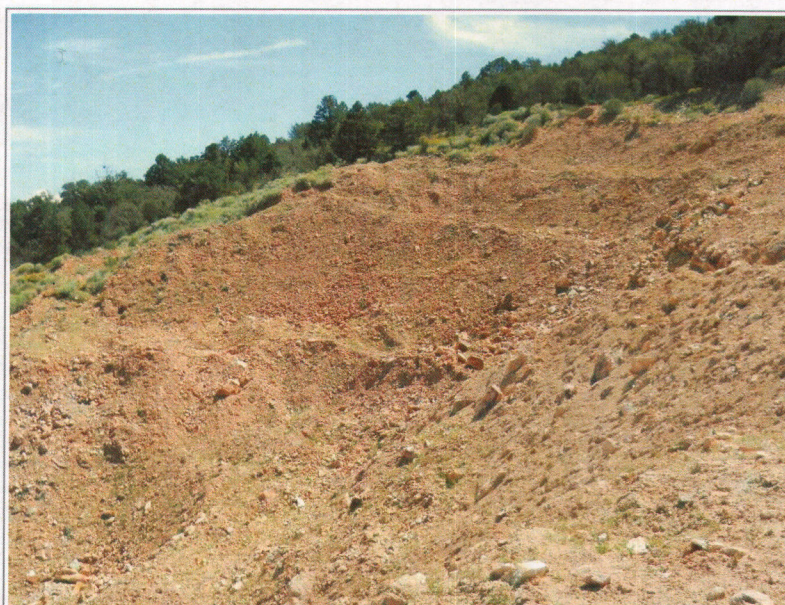
View of slopes from the side. Note the steepness and the terraces/benches.

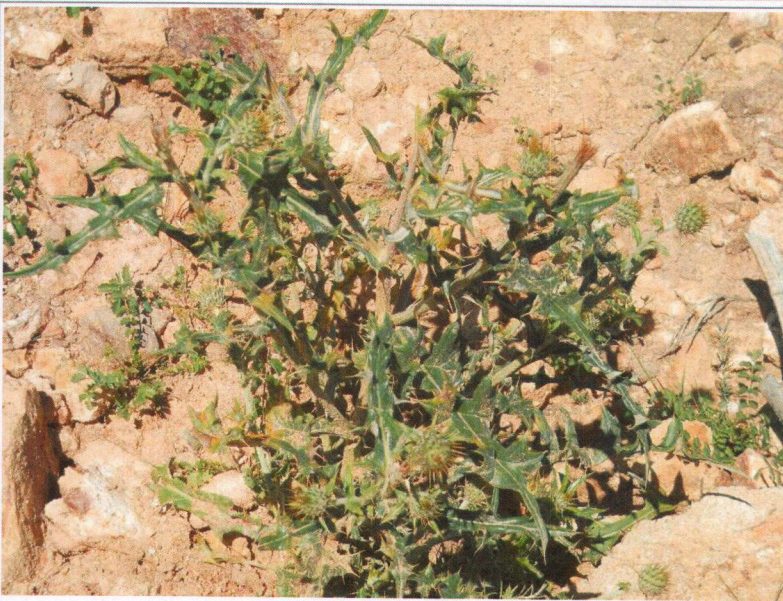
A probably-native thistle that is not noxious (one of a couple found).

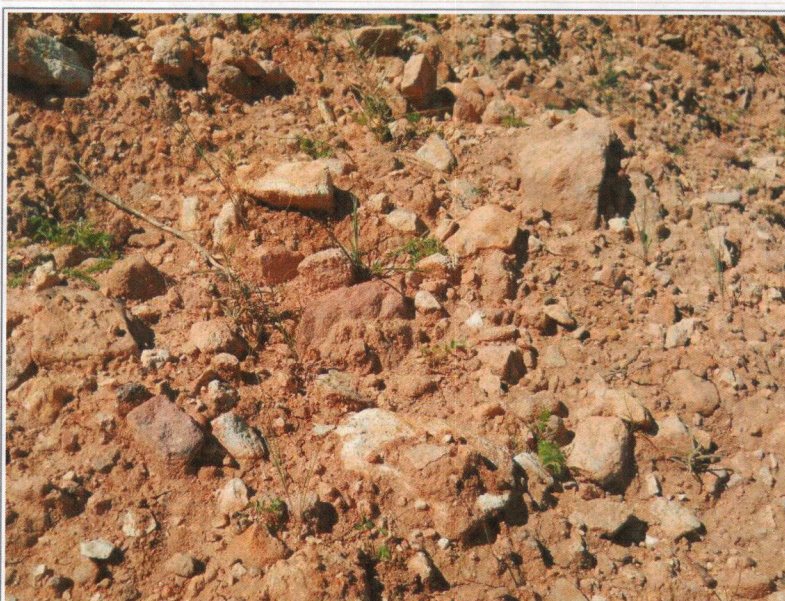
Example of seeded species (small burnet, multiple grasses) and rabbitbrush.
